REPAIRS TO HERITAGE VERANDAH

LOCATION	215 Forbes St, Darlinghurst	YEAR	2009	BUDGET	\$30,000
ENGINEER	Hughes Trueman P/L (Amir Bagheri Ph. 9439 2633)				
CLIENT	SCEGGS Darlinghurst School (Mick Vidovic Ph. 9332 1133)

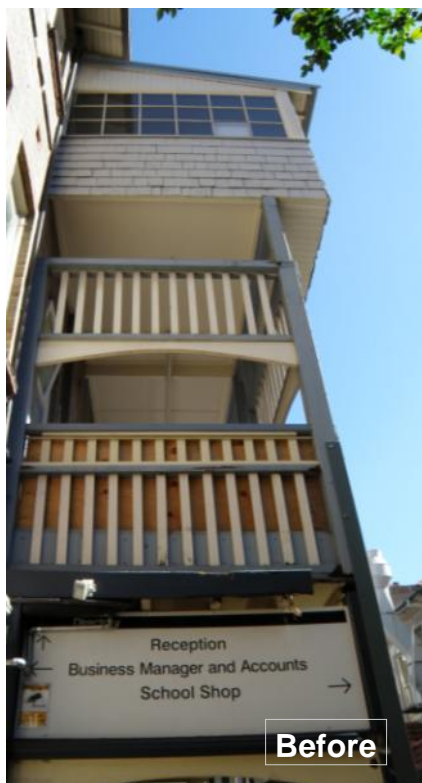
Before

SCEGGS Darlinghurst contacted Coleman & Fairburn with a problem: part of the timber verandah of the 1833 'Barham' building (on the National Estate Register) was badly rotted and needed replacing. Compounding the problem, the rotted corner post supported an enclosed verandah at the 2nd floor level housing computer classes. With careful planning, Coleman & Fairburn replaced the rotted structural timbers in the first bay of the verandah during a 3-week school holiday period. Timbers were replaced like-with-like and Coleman & Fairburn's own Joinery Shop matched the original profiles where necessary. Trishore Props and a steel beam supported the 2nd Floor classroom while the corner post was replaced.
